# Manhole Inspection Summary

Manhole # S4300\_013MH

Insp Date: **6/25/08 10:27 AM**

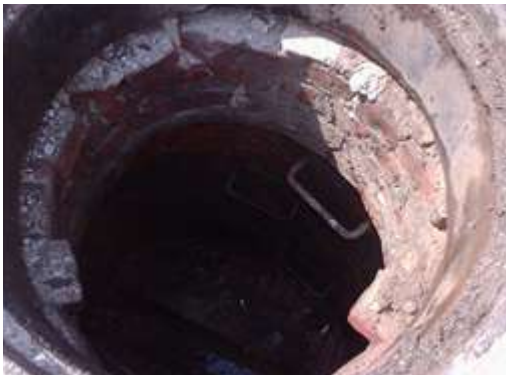
Defect 1

Condition: ☐ Sound ☐ Cracked ☐ Root Intrusion ☒ **Loose Brick** ☐ Deteriorated

Infiltration: ☐ None ☒ **Joint** ☐ Cracks ☒ **Mortar** ☐ Roots ☐ Wall

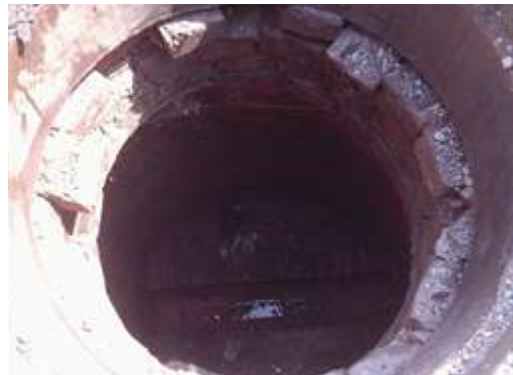
Defect 2

Infiltration: ☐ None ☐ Joint ☐ Cracks ☐ Mortar ☐ Roots ☒ **Wall**

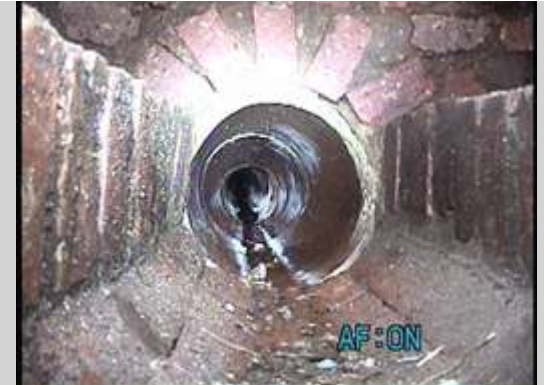
12 O'Clock Outflow

8 in. Circular Gravity Sewer  
Pipe Out @ 12 O'Clock

Pipe Height: **8.4** (in.) Rod and Bar (Angled)  
Pipe Material: **Clay** ☐ Pipe Lined  
Invert Depth: **7.70** (ft.) Flow Characteristics: **Slow**  
Deposits: ☒ None ☐ Mud ☐ Sludge ☐ Debris ☐ Grease  
Silt Depth: (in.) Deposits Extent:  
Infiltration: **None** Pipe Seal Cond: **Sound**

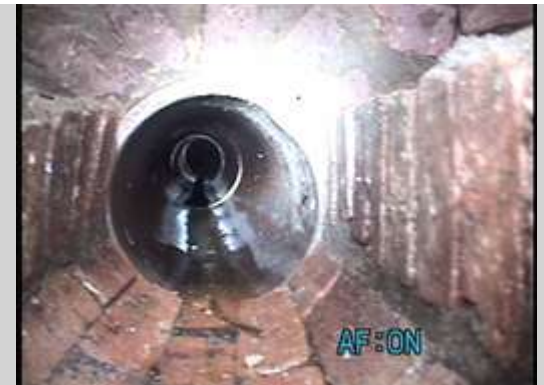
6 O'Clock Inflow

8 in. Circular Gravity Sewer  
Pipe In @ 6 O'Clock

Pipe Height: **8.4** (in.) Rod and Bar (Angled)  
Pipe Material: **Clay** ☐ Pipe Lined  
Invert Depth: **7.65** (ft.) Flow Characteristics: **Slow**  
Deposits: ☒ None ☐ Mud ☐ Sludge ☐ Debris ☐ Grease  
Silt Depth: (in.) Deposits Extent:  
Infiltration: **None** Pipe Seal Cond: **Sound**
